Monitoring work

Construction sites and grazing workshops are just the beginning - monitoring is an ongoing and integral part of the Herbert Gully and Grazing Project.

ABOUT THE HERBERT GULLY AND GRAZING PROGRAM

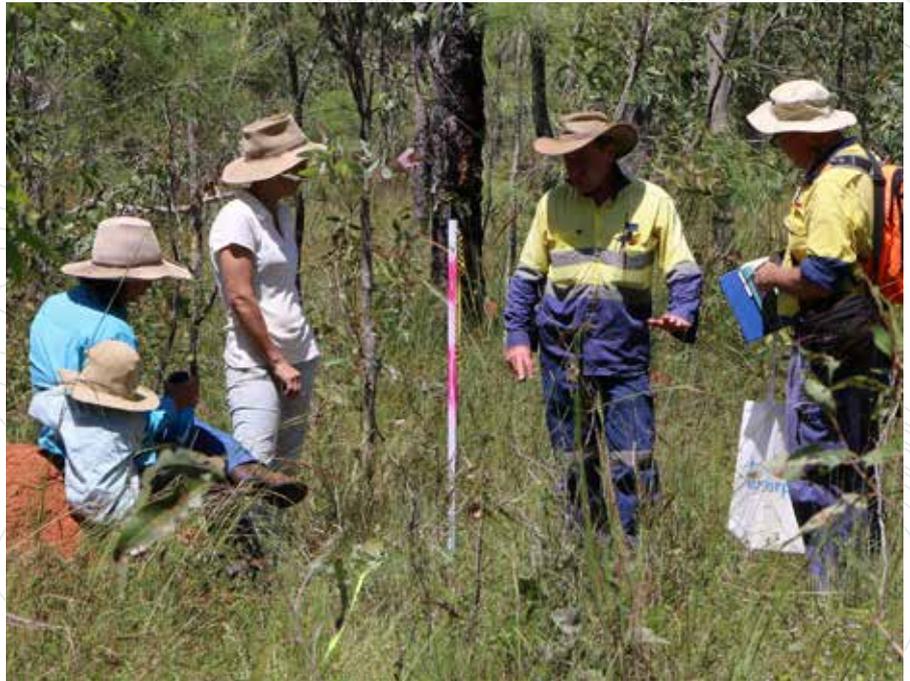
Annual inspections are an important follow-up. Sites are monitored several times each wet season, as access permits, to assess structural integrity. Each structure is inspected in its entirety, along with the surrounding area. Camera and drone photos are also taken. Landholders are often part of the inspections, to gain their perspective on remediation sites and how they are performing.

As a result of inspections there has been minor maintenance work on four structures, including adding a little more rock to chutes and bund wall aprons.
